# THE WHITE PALACE, PROTECTING CULTURAL HERITAGE OF SWAT

M.Zeshan # 01, Emran Khan Mahmood # 23, M.Younas # 30, Amir Khaliq # 50

SIR AZMAT, semester 9th , Batch # 9th

Protecting cultural heritage of swat

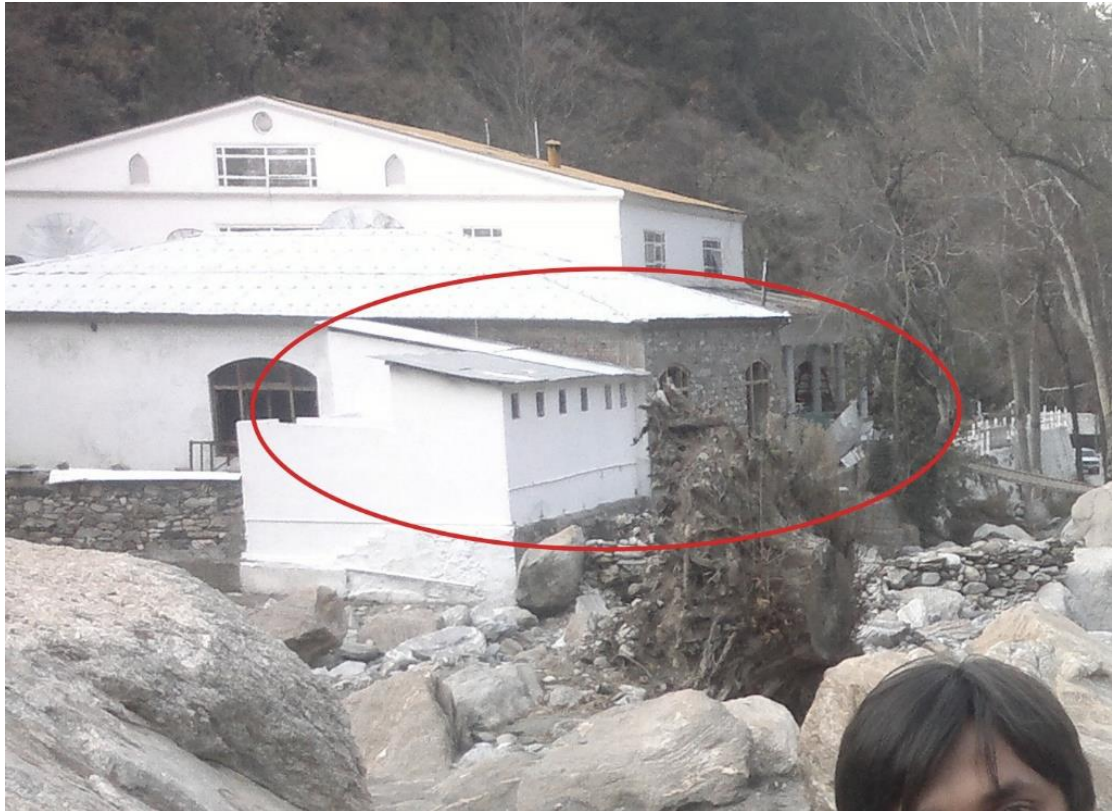
The floods hit the white palace and destroying one portion of the hotel and left it devastated.

In 2010 heavy floods struck the hotel and damaged two parts of the building which got relocated and rebuild. It just rained for four hours and a huge torrent of water came that rose to 3 ft level at the palace.

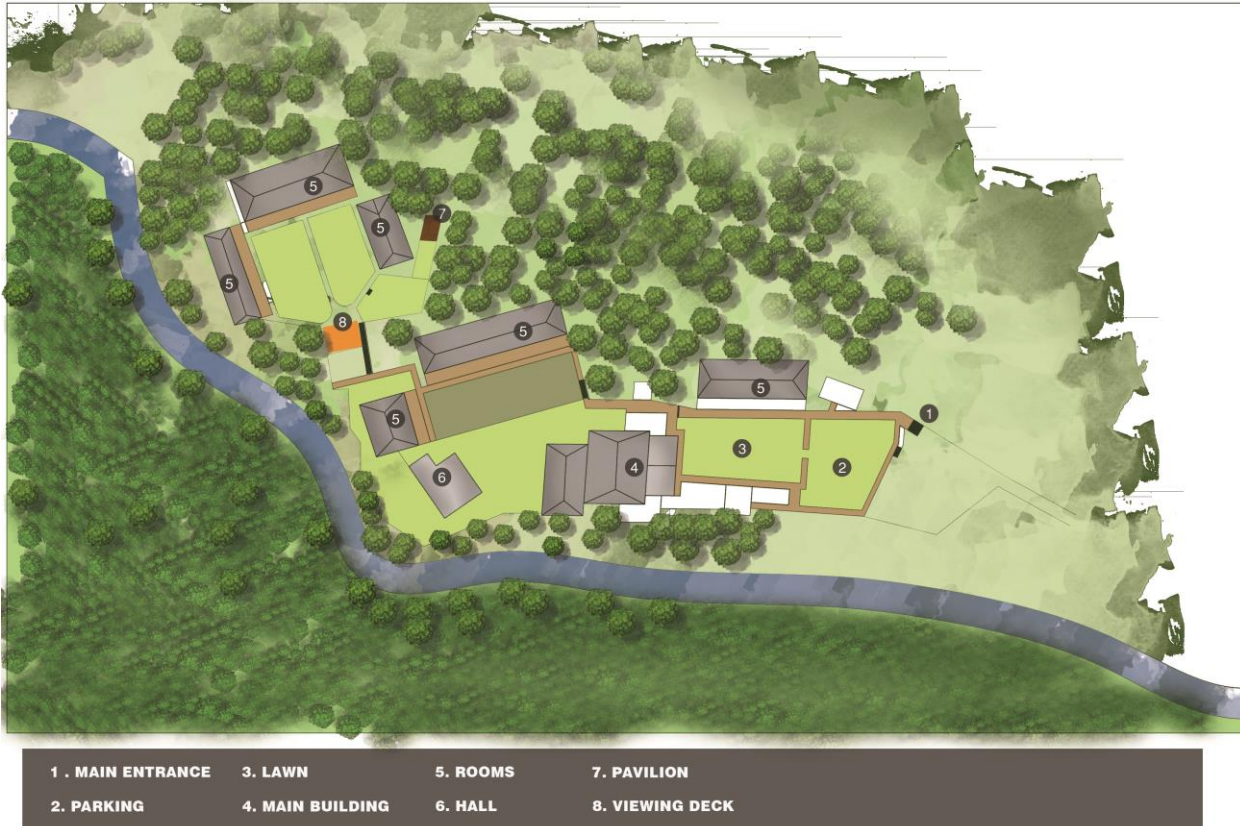
#### 3.1 MASTERPLAN

1. Starting from main entrance follows with car parking, Next to car parking is located the main lawn (garden).
2. Attach with the garden on south side is the main hotel building and west are First set of rooms
3. There are 24 beautiful big rooms in palace and the big one royal room
4. It have two big conference halls
5. There is a kings entry way

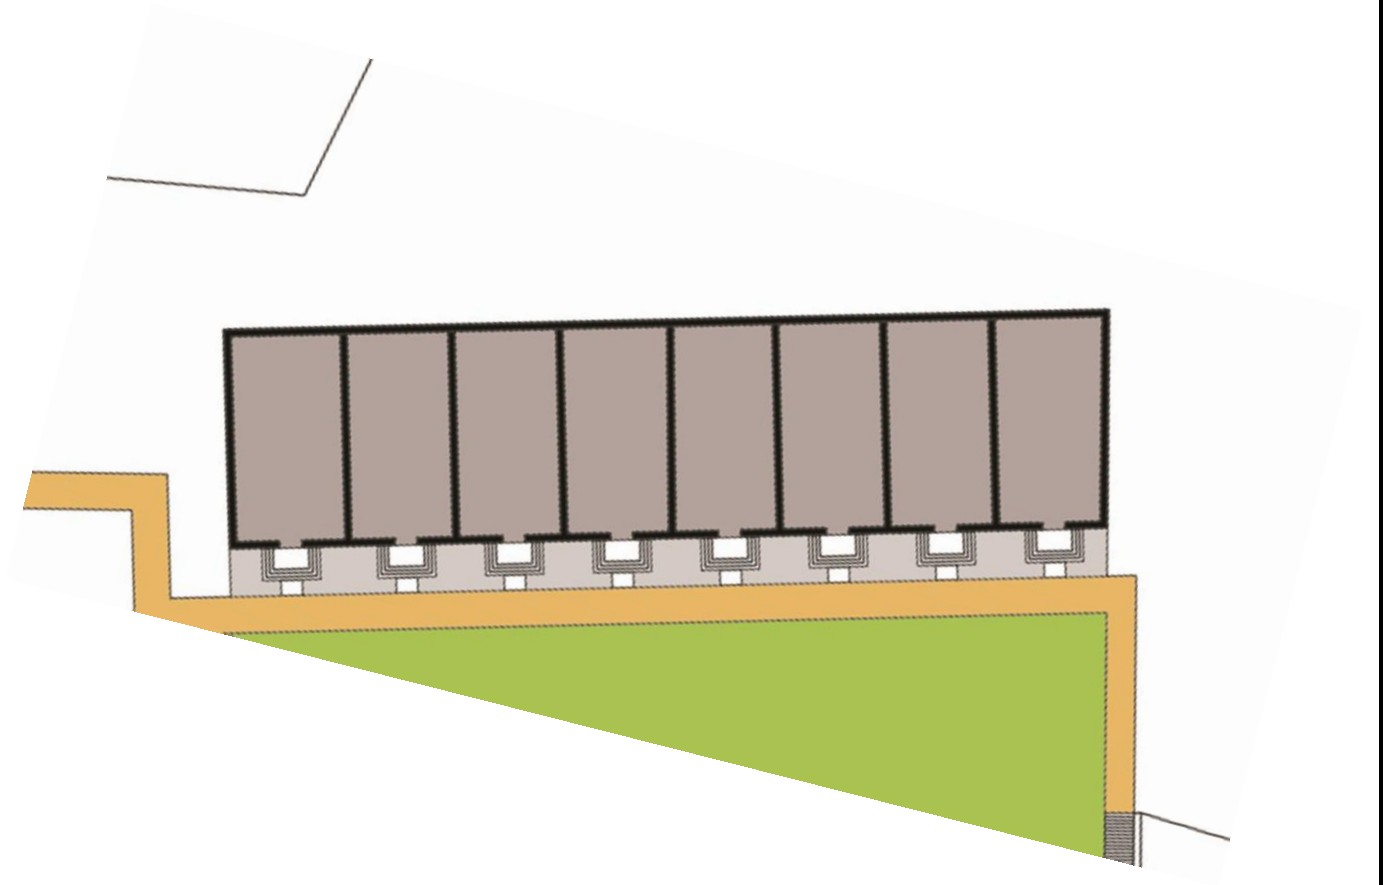
### 3.1.1.2 ROOMS FLOOR PLAN

- 24 well decorated rooms
- Prince block 8
- Queen blocks 12 with balcony having 12 marble benches and tables
- 4 servant room
- 1 royal suite
- 2 big conference hall
- Kings lobby
- mini zoo
- Lawns
- Dining hall

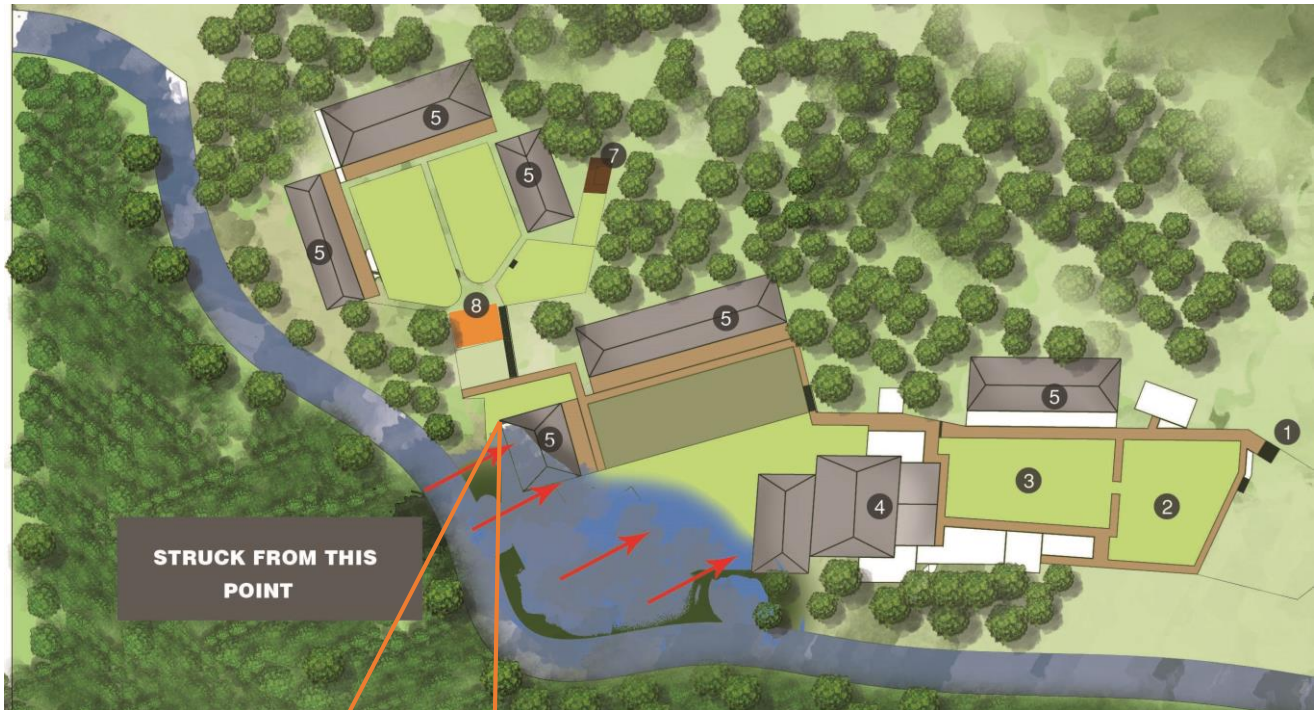
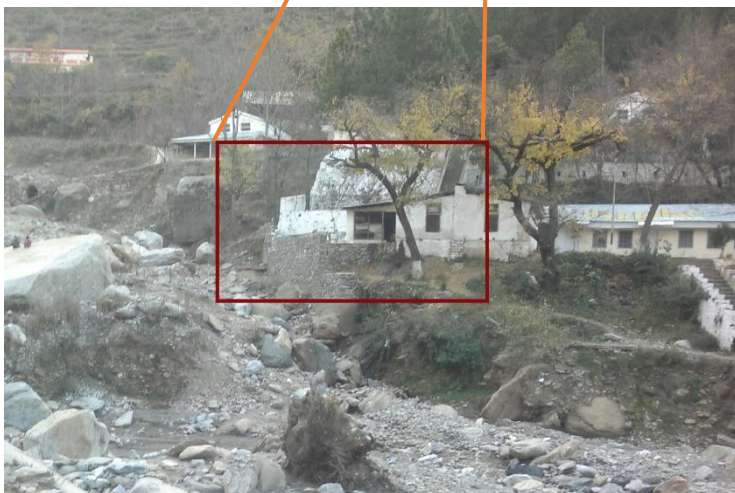
### 3.3 AFTER FLOOD SCENARIO:

Flood in 2010 washed away the backside of the palace having

- Water bank
- Bridge
- Washrooms
- A small lawn

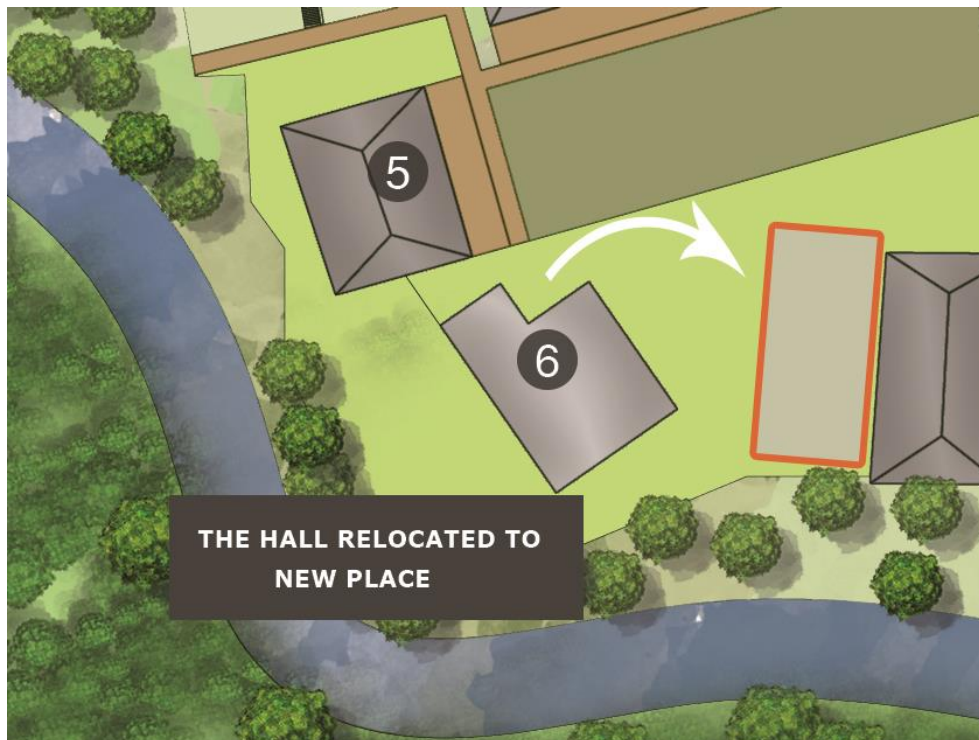
The hall was relocated to new place near the main hotel building:

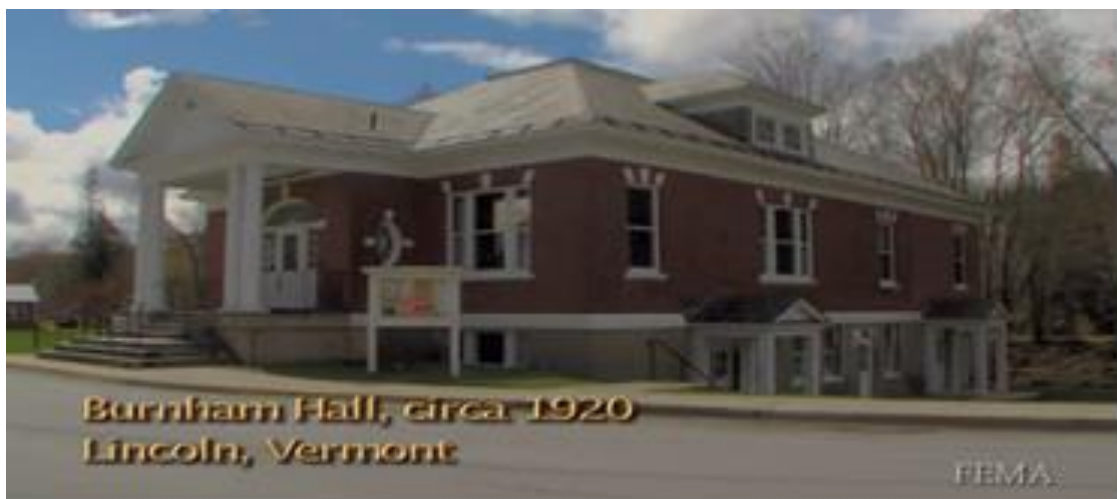
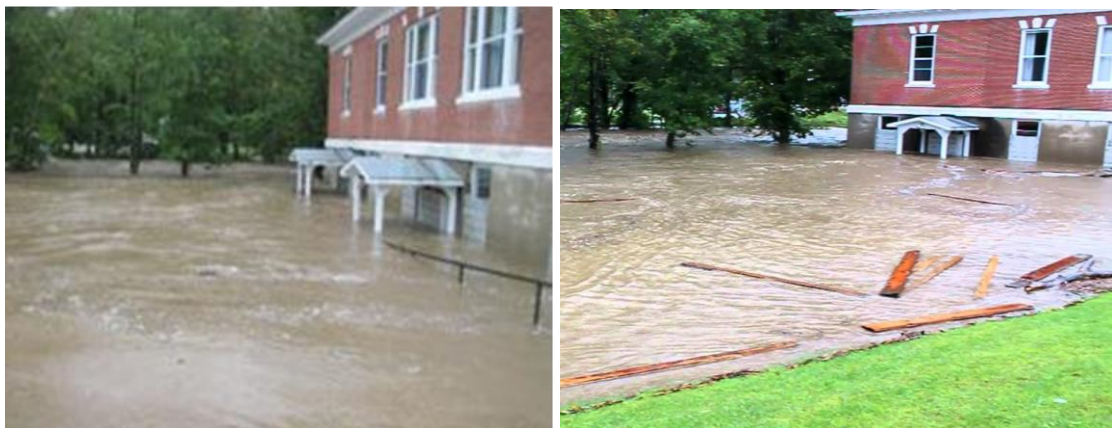
Overview Burnham Hall, Lincoln Vermont's community center, was built in the 1920s within 10 feet of the New Haven River. On average, it has flooded once every 12 years. In 1998, after the hall flooded with over five feet of water, the library had to be relocated. As the waterlogged books were being moved from the lower floor, Harriet Brown, a long-time Lincoln resident, rallied the community to support a project to protect Burnham Hall from future floods.

A volunteer community group obtained a grant from the Agency of Natural Resources to study how to relocate or retrofit the building. The goal was to "live with the river for the next 100 years." After reviewing the report, the committee decided to incorporate flood proofing techniques with a Hazard Mitigation grant from the State of Vermont and the Federal Emergency Management Agency (FEMA).

The flood defenses of the building included five significant construction elements.

The height of foundation wall was increased three feet above the floor slab. Fortunately, the original garage building also had a high foundation wall providing a flood barrier at that section of the building. The perimeter wall protects against high water. The riverbanks outside of this corner was also strengthened with heavy stones.

The southwest corner, closest to the brook and facing upstream, was the most susceptible to impact from debris carried by a flooding river. All other flood control measures would be ineffective if the perimeter wall was damaged by a floating tree trunk. To reduce this threat, an eight ton block of concrete, reinforced with steel bars, was constructed into this corner of the building.

Flood control assumes that some water may get in. Therefore, there is a need to reduce the damage if it does. To this end, all the gypsum wallboard – a material that absorbs water – was removed and cement board was installed one foot above floor level. The cement board retains its integrity when wet, and it does not wick water up into other parts of the wall, which often causes mildew.

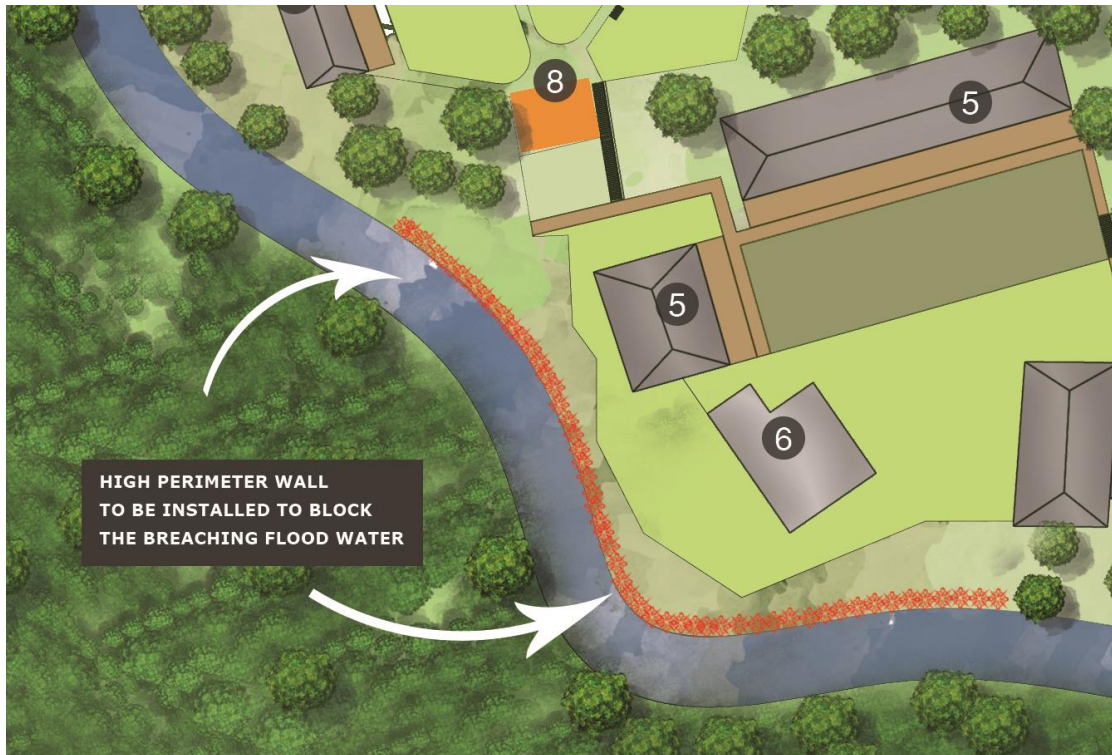
### 1. HIGH PERIMETER WALL :

High perimeter wall to be installed to prevent the flooding water to breach the perimeter line .The height of the wall will help keep the rose water level from overflowing

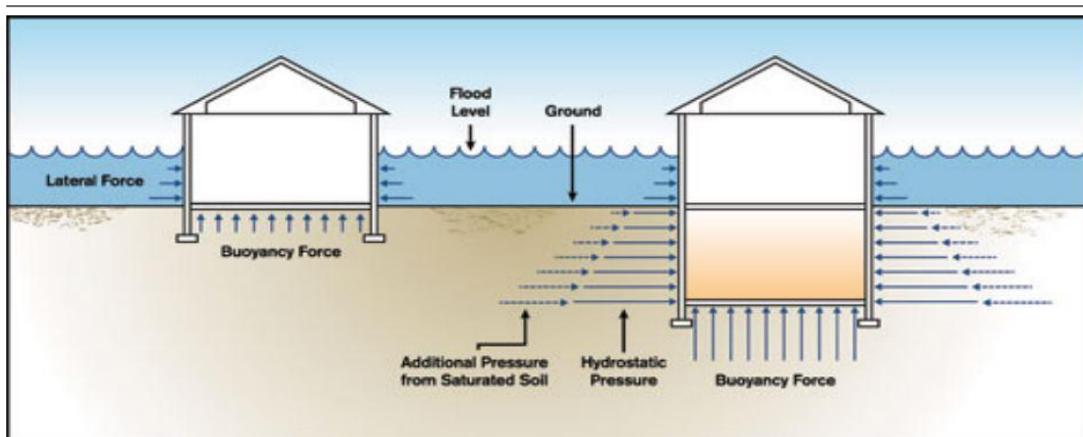
### 2. FLOOR RESISTANT TO HYDROSTATIC PRESSURE

New construction must be installed with special hydrostatic pressure floors. To resist buckling from rising groundwater.

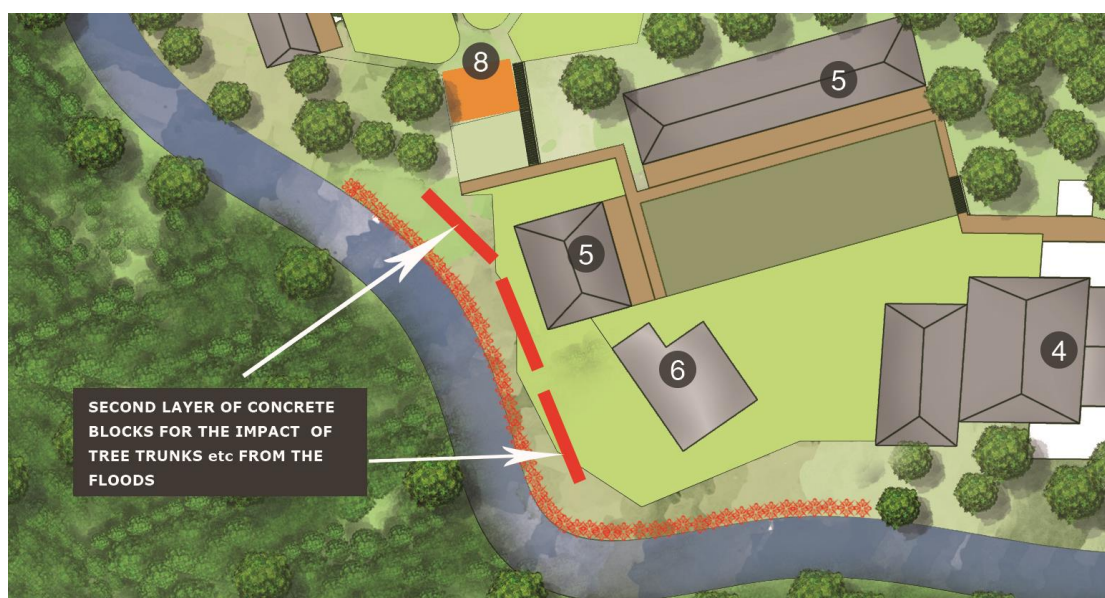
### 3.IMPACT PROTECTION:

Second layer of concrete blocks to be added to strengthened the vulnerable breaching point and provide protection by the strong impacts by tree trunks and other heavy objects carried by the flooding water with great speeds.

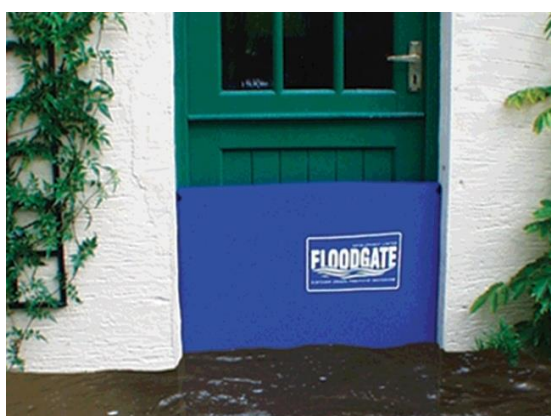
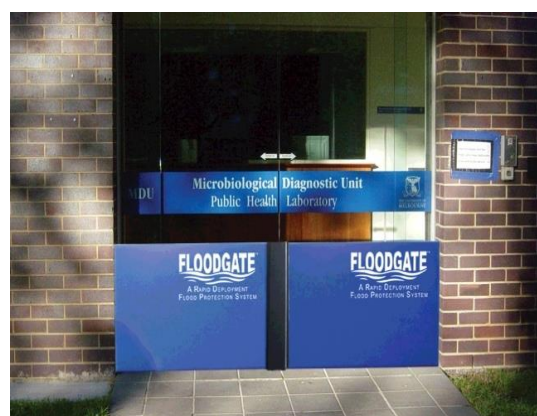
### 4. FLOODGATES :

Flood gates to be installed at every door opening at the hotel building. This will help in preventing the water from entering the building upto some extent incase the other perimeters are breached.

Finally, the five doorways had to be protected from floodwaters. The solution was inexpensive and effective: flood gates were made for each door, the gates consisting of ¼” thick aluminum sheets that slide into tracks at each side of the door frame, and tighten against gaskets with a set of thumbscrews. The gates are located inside rather than outside to allow the doors to swing outwards and let people out.

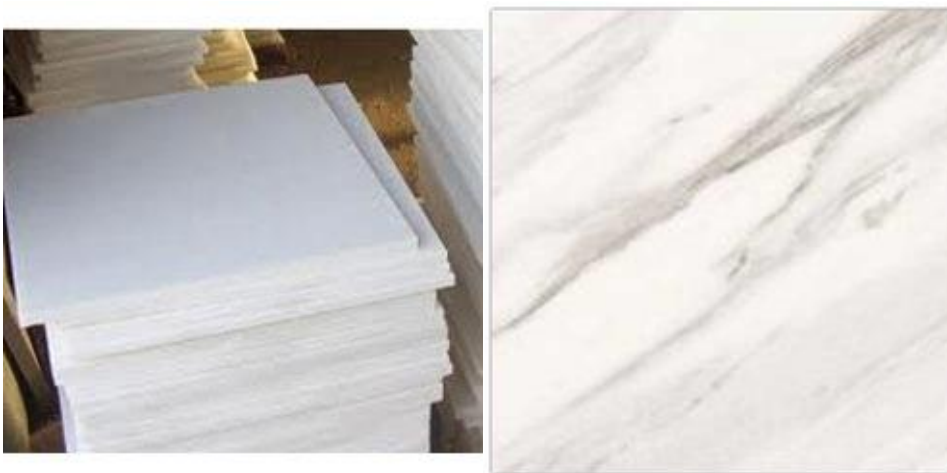
White marble

The white marbles for this structure were brought from the marble quarry in Jaipur in India, the same quarry from which the Taj Mahal's marble came from.

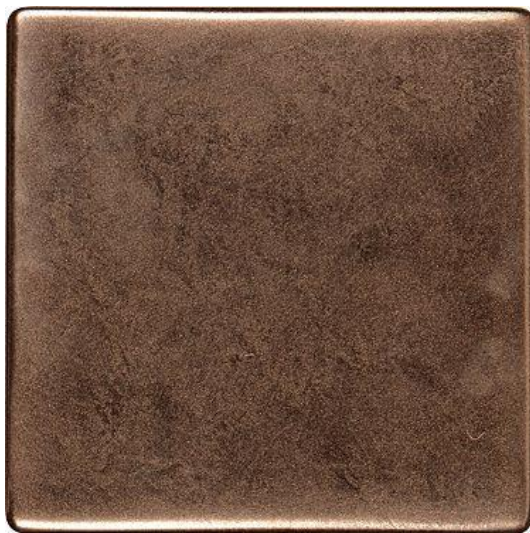
Bronze on the ceiling.

Its bronze, used in the ceiling, was brought from Belgium, and its artisan from Turkey. Its ceiling fans and its electrical equipment were imported from England, and they're all still working.

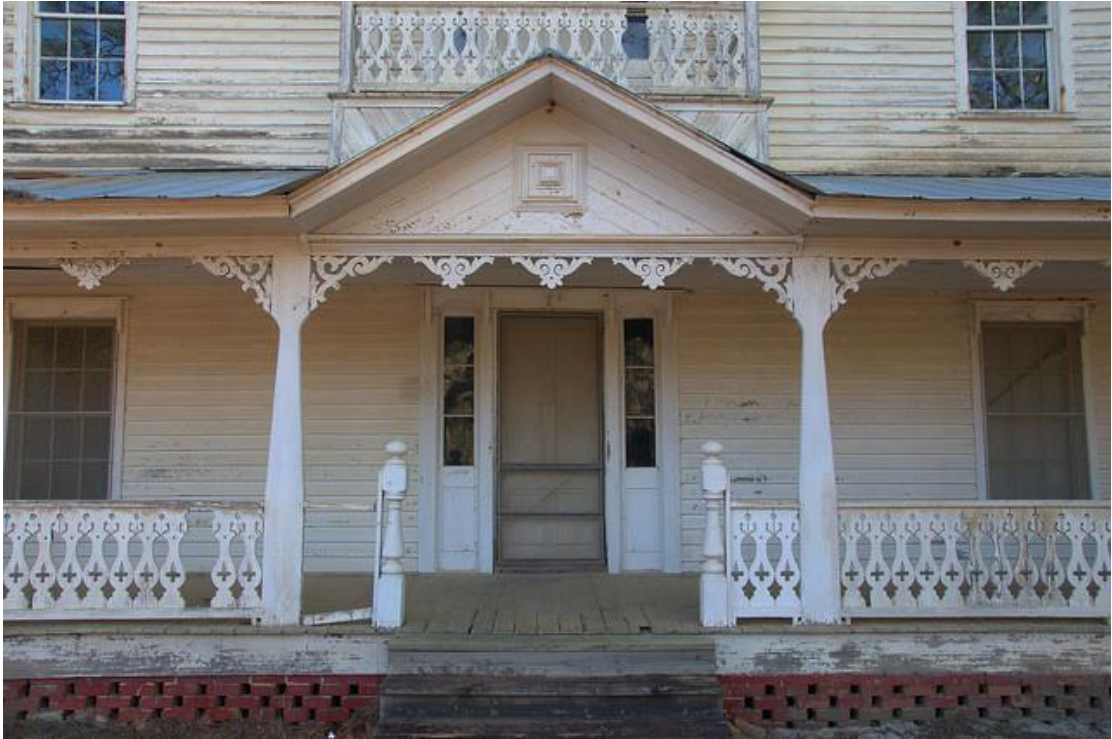
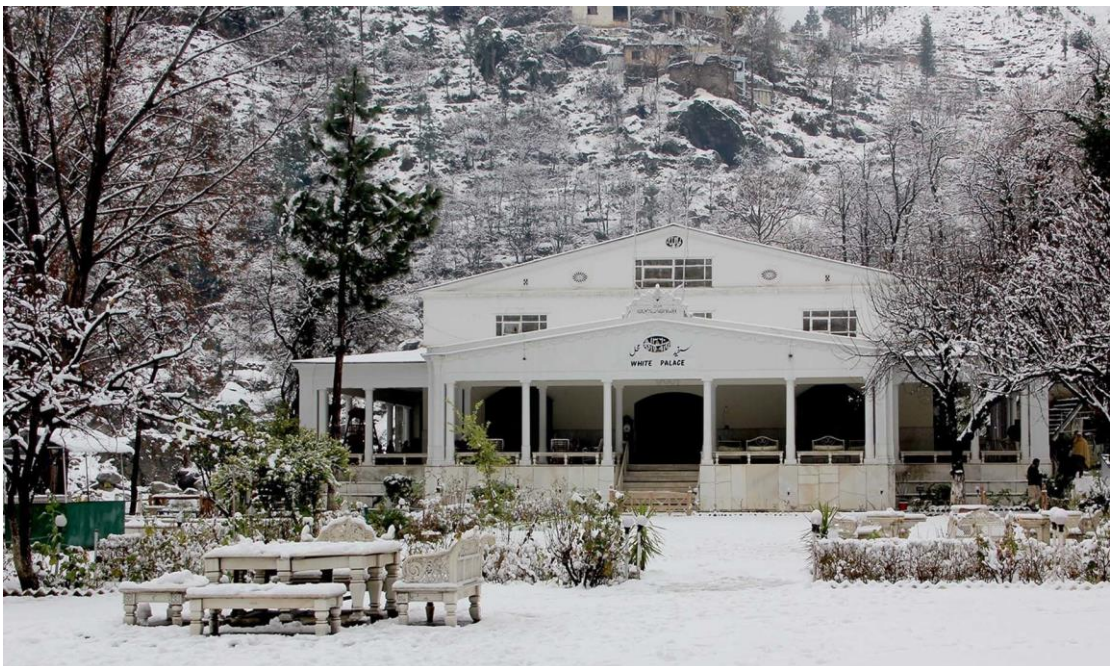
## 9.2 MASONRY:

It was the first building in the entire region constructed on Victorian architecture. It has a multilayered roof, starting from a bronze layer to the wooden layer of deodar tree, lime layer, mud layer, and again a deodar layer with an iron layer to the outer top.

“It was the first structure in the whole region constructed on Victorian architecture. It has a multilayered roof, starting from a bronze layer to the wooden layer of deodar tree, lime layer, mud layer, and again a deodar layer with an iron layer to the outer top.”
